Meeting regarding the Former J.H. Baxter Arlington Facility
March 23, 2015 10-12 AM

EPA Meeting

J.H. Baxter Arlington

Chem-Ox Study

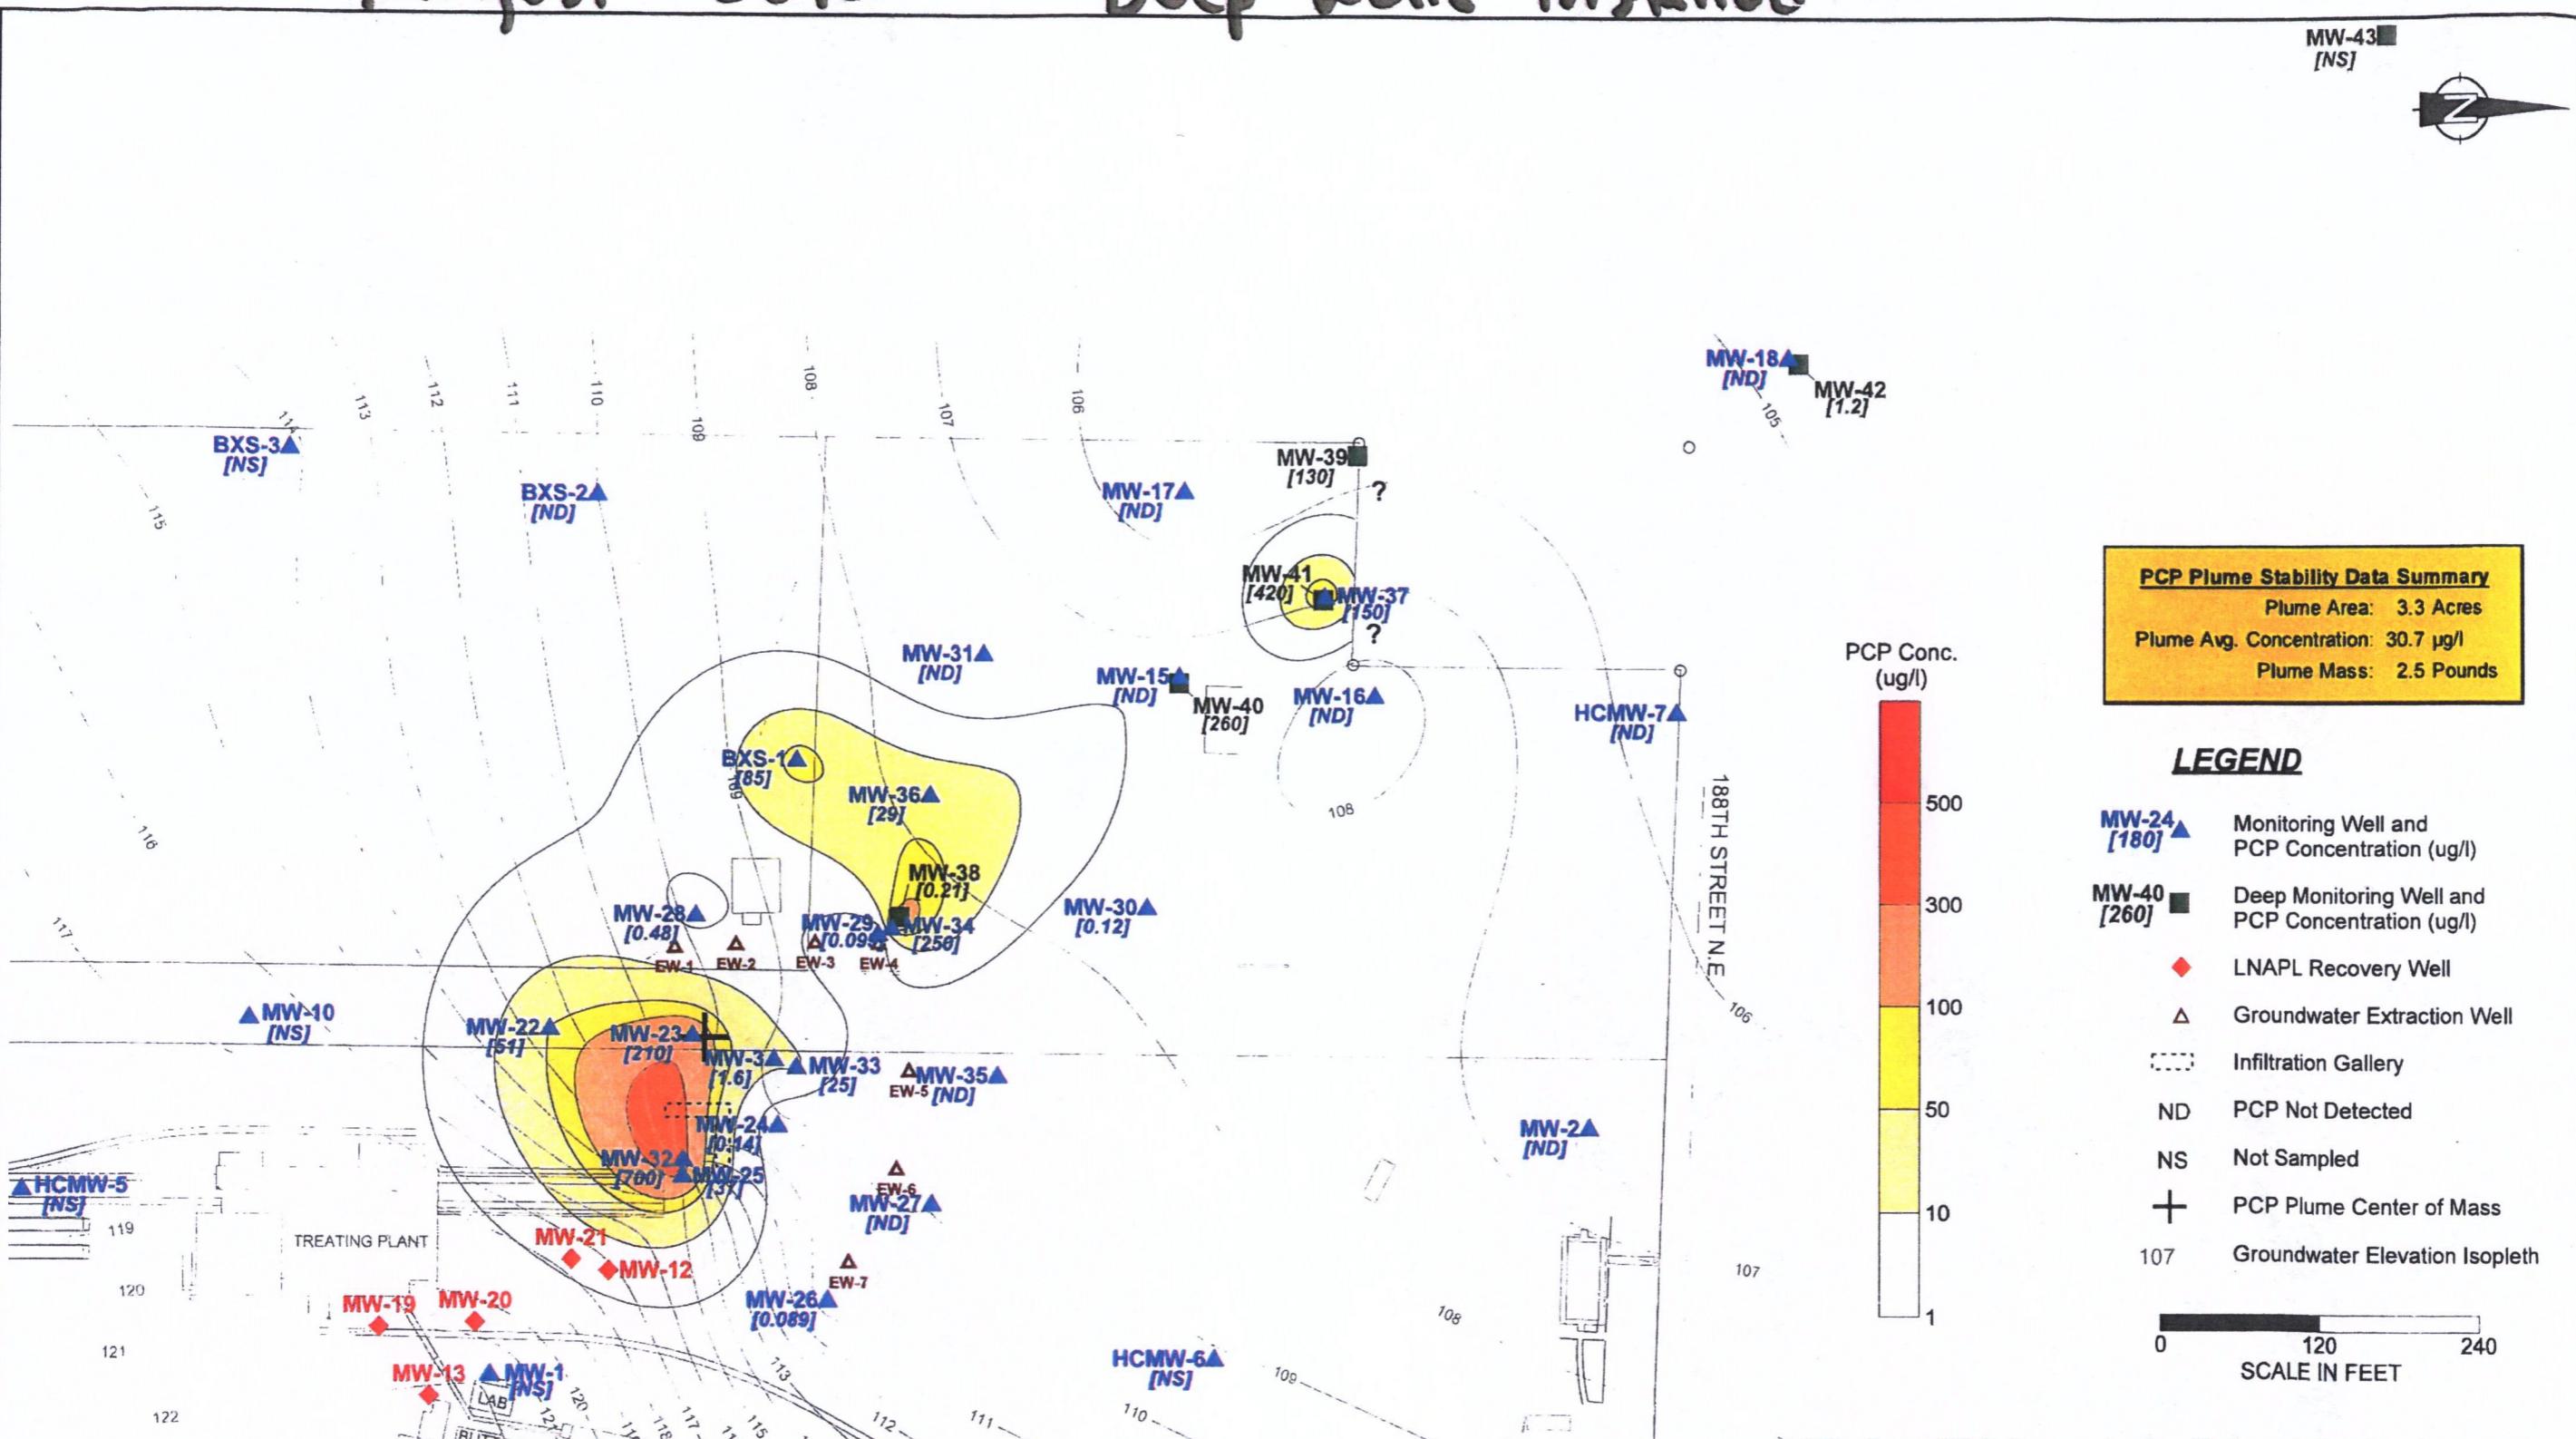
Figure 17

PENTACHLOROPHENOL ISOPLETH MAP - August 2010
Former J.H. Baxter and Co. Wood Treating Facility
Arlington, Washington

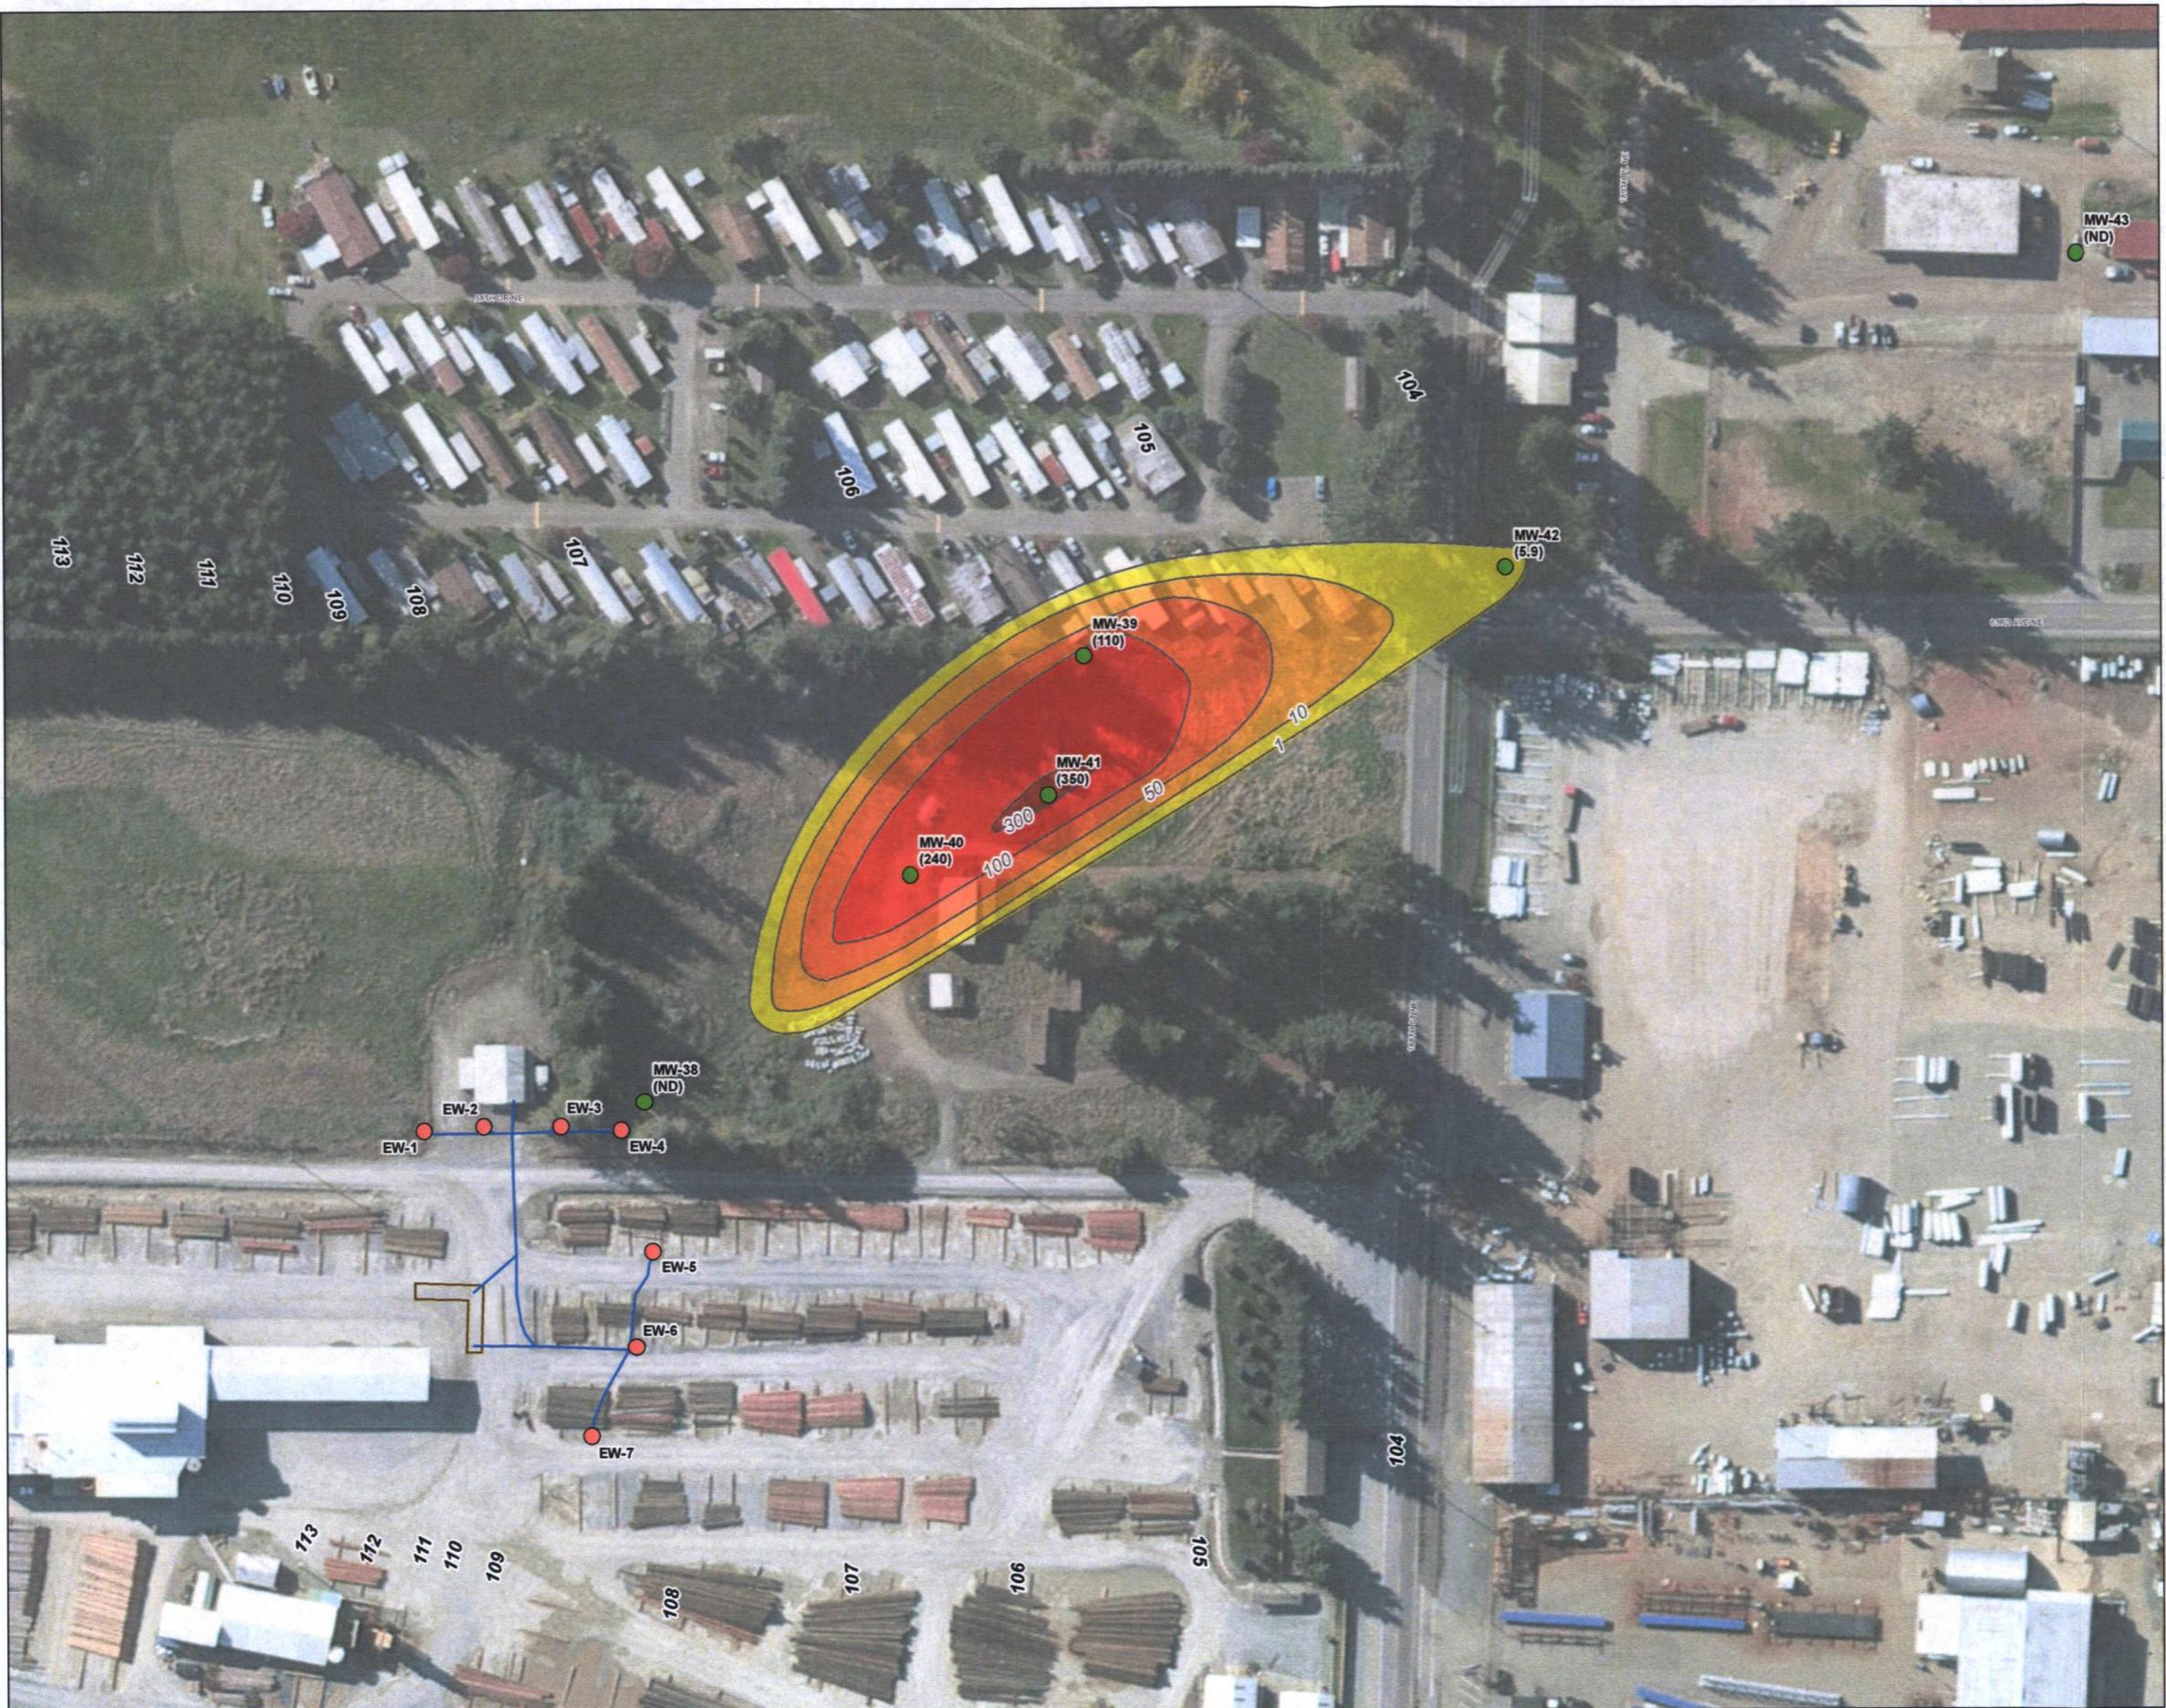
FIGURE 20

Pentachlorophenol Isopleth Map,
Deep Zone:
Fourth Quarter 2014

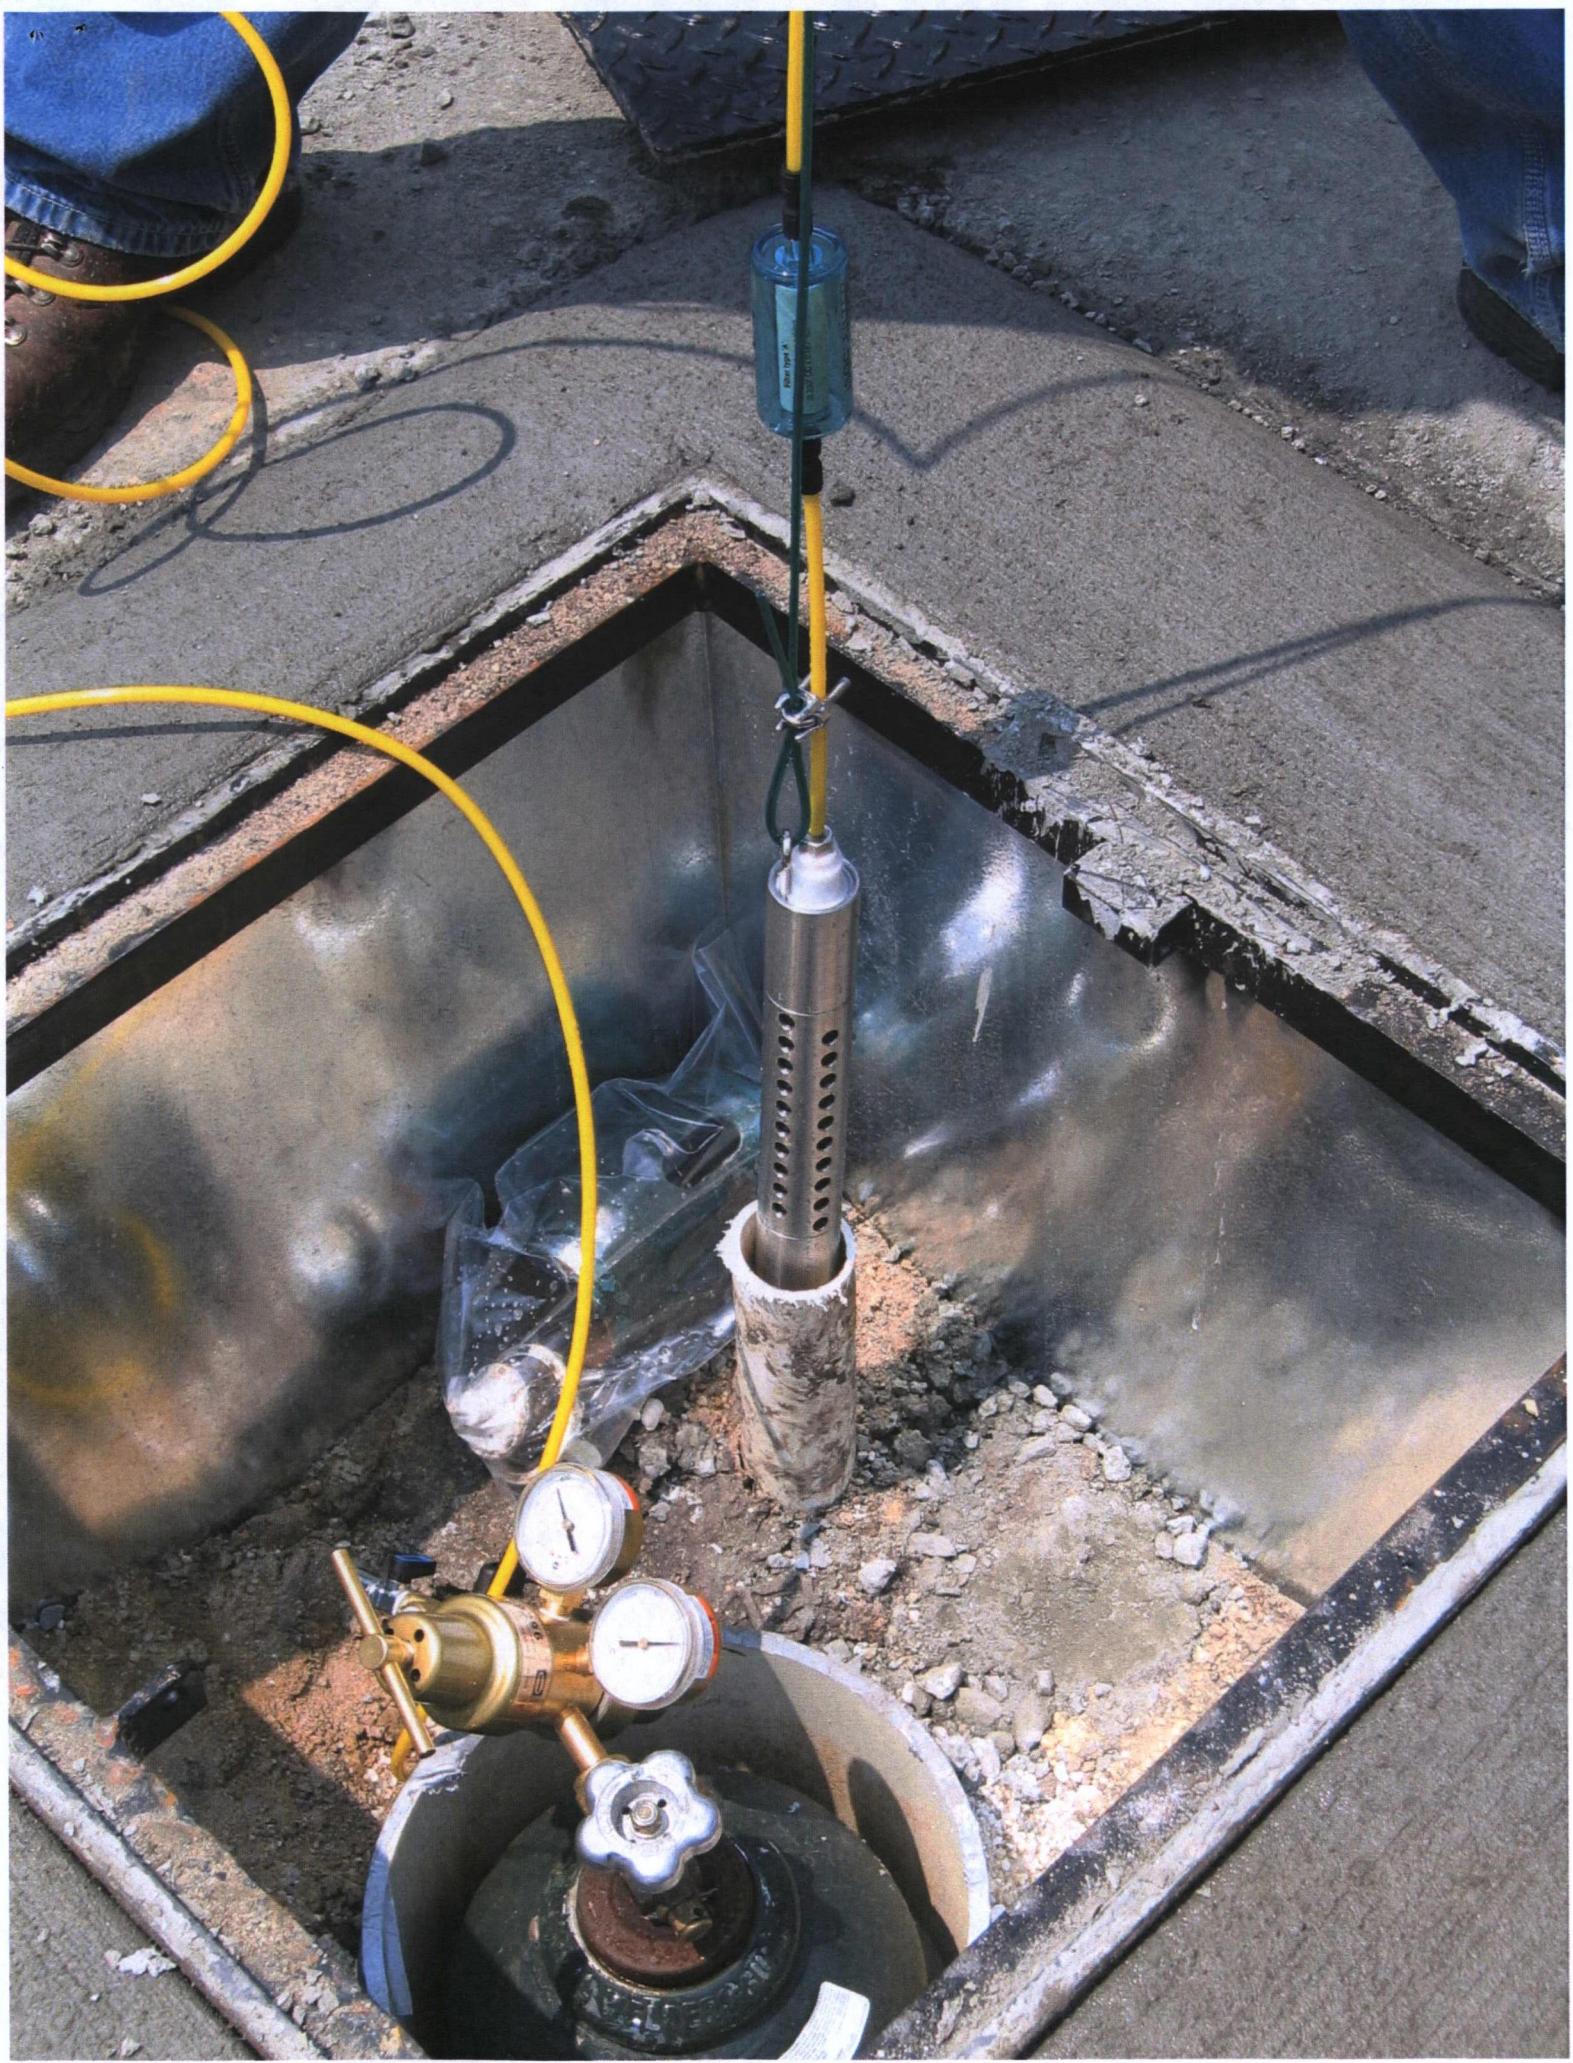
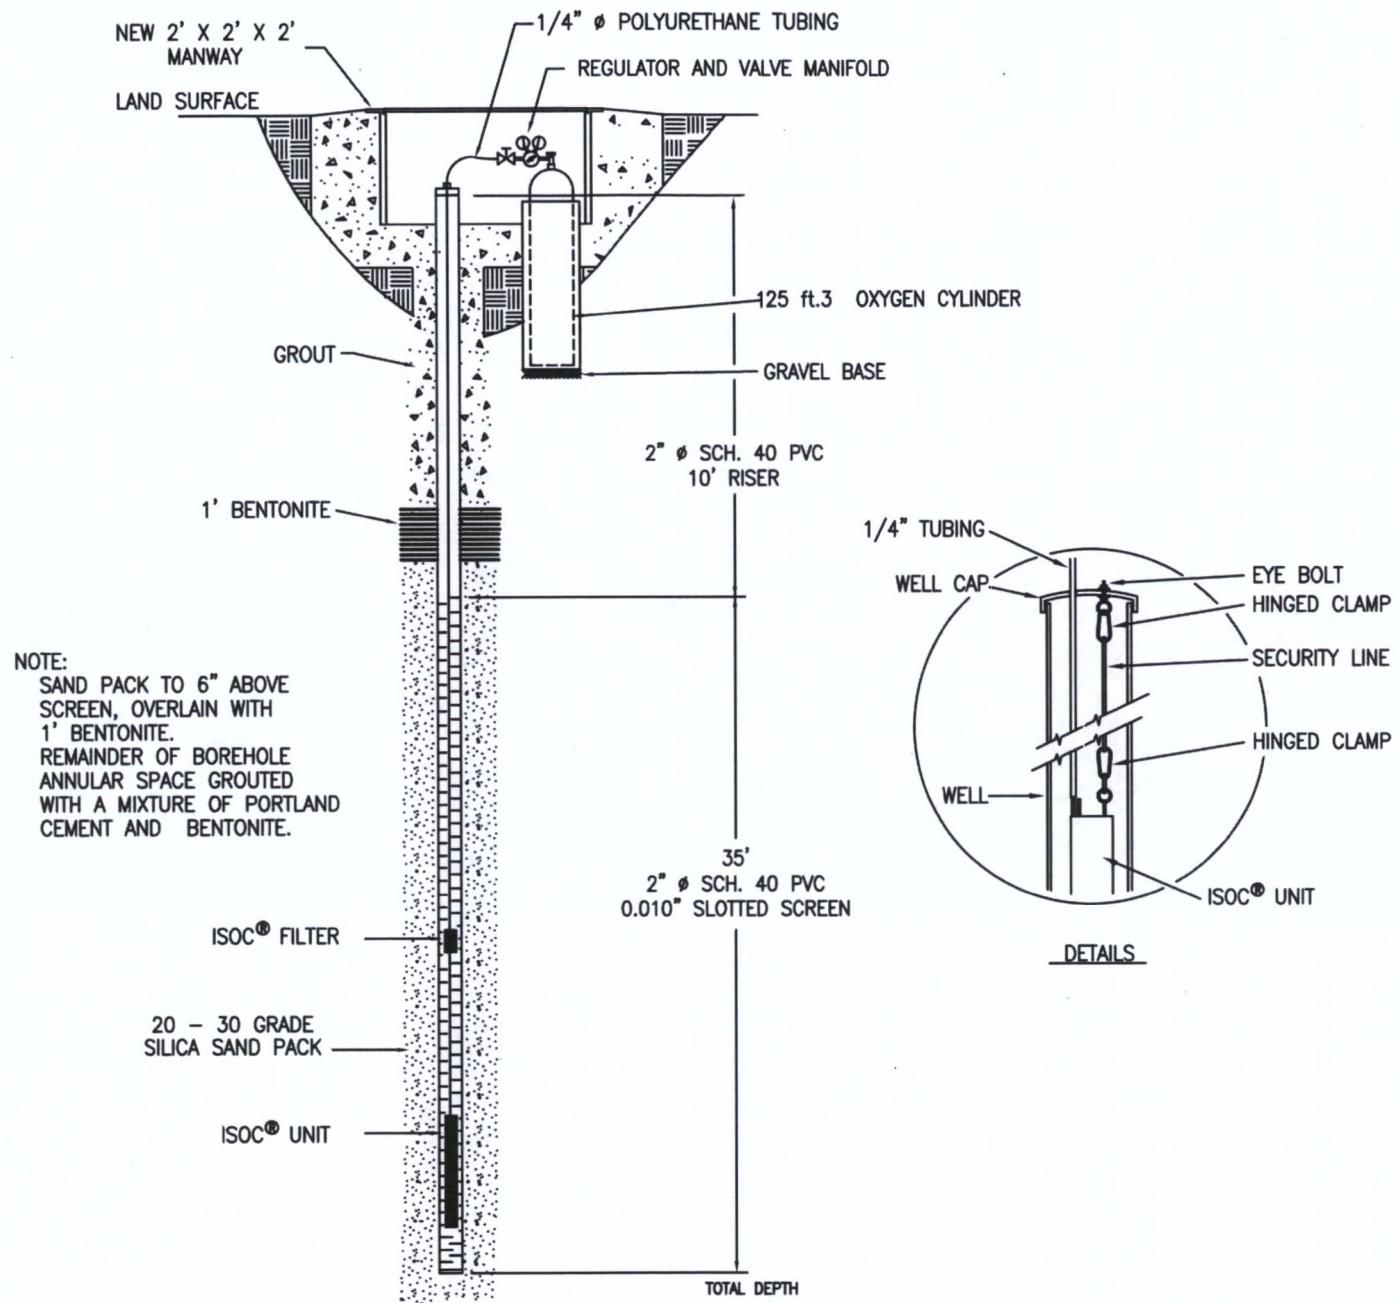
ISOC® WELL DETAILS

- Add iSOCs to 3 downgradient intermediate wells to enhance biodegradation of the cut-off plume
- Evaluate Recirculation trench to understand where the biofouling is occurring, discuss with EPA, and prepare a work plan to rehabilitate recirculation trench
